THE ROLE OF METALLURGY IN AIRCRAFT ACCIDENT INVESTIGATION AND LITIGATION

For the purposes of our demonstration, please assume that a light, single-engine aircraft crashed on landing. The pilot was a high-time instructor and the passenger was a student. Ground witnesses reported that when the aircraft was at about 800 feet on final, it made an uncontrolled bank to the left and crashed.

point where the cable's strength ultimately became so low that it failed while the aircraft was on approach. Plaintiff claims that this caused the left flap to retract, as a result of which the pilot lost control. The defendant-manufacturer maintains that the accident resulted from pilot error or incapacitation and that the flap cable, Exhibit 1, failed in overload on ground impact.

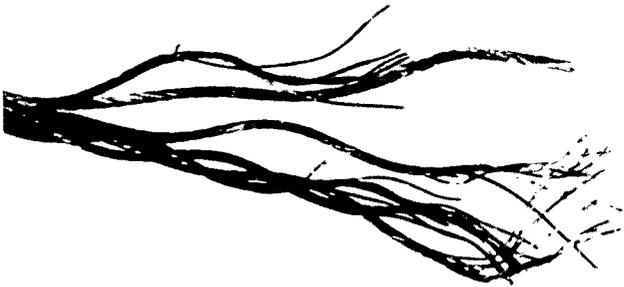
EXHIBIT 4

AST: Certainly. The allegation has been made in this case that the failure has occurred progressively because of the unravelling of the cable. Now, there was also a second control cable that was located adjacent to the one that is the subject of this lawsuit. The second failure had taken place by overload. That failure occurred in the E cable. Exhibit 4 shows that in overload fracture unravelling of the strands has also taken place. This tells us that the presence of unravelling does not prove the presence of progressive fracture, since we have unravelling in a cable that has failed by overload.
